Westmill Solar Park

Quarterly Report – January, February and March
2019

Westmill Solar Cooperative

P0014354 Westmill 2019

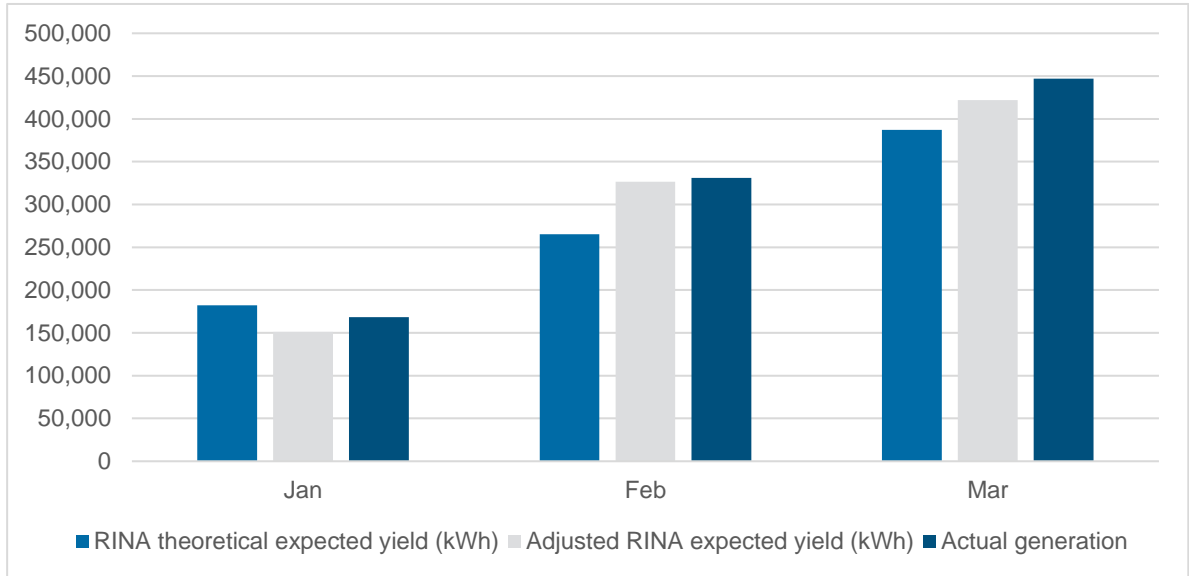
Figure 1: Monthly generation

Figure 1 compares the expected yield from the original yield study and actual plant generation for the quarter. The expected yield is then adjusted with the actual irradiation and availability data for the period to show the adjusted RINA expected yield (kWh). Actual plant generation is taken from the DNO export meter readings which have been verified using the Skytron monitoring system for each month of the period.

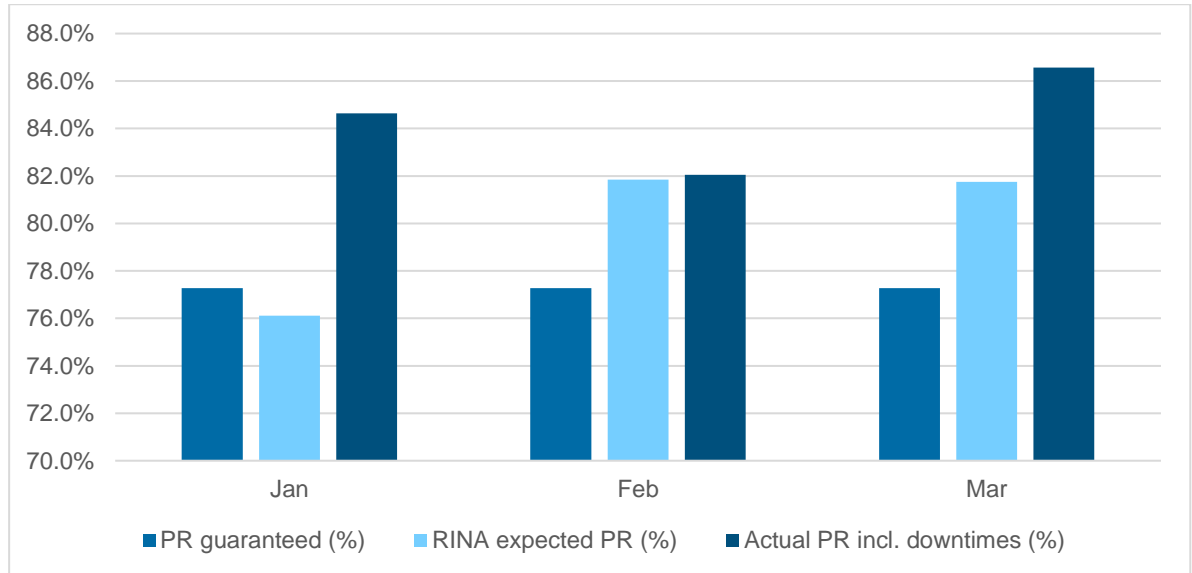
Figure 2: PR analysis including downtime

Month	RINA expected PR (%)	PR guaranteed (%)	Actual PR incl. downtimes (%)	Delta Actual to RINA expected (%)
Jan	76.1%	77.3%	84.6%	11.2%
Feb	81.8%	77.3%	82.0%	0.3%
Mar	81.7%	77.3%	86.6%	5.9%
Q1 2019 Total	80.5%	-	84.6%	5.1%
Q1 2018 Total	80.8%	-	83.1%	2.8%

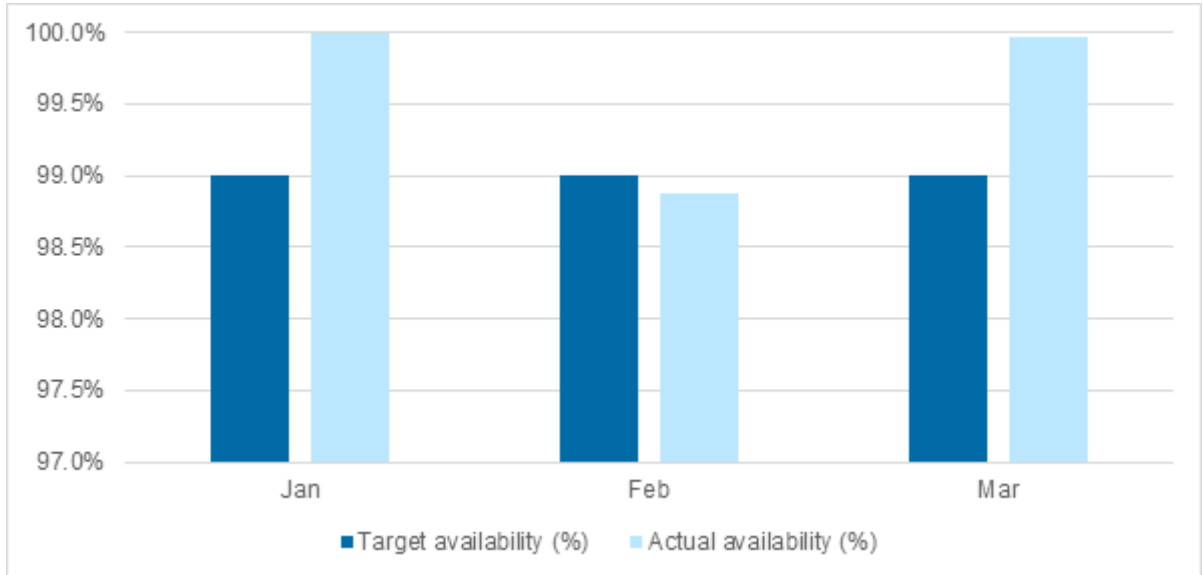
Figure 3: Target and actual availability

Based on the information received from British Solar Renewables O&M (BSR O&M), availability in February 2019 was low due to the DNO outage (reference number: F19-401-A) at Westmill Solar Park from 08:00 to 18:45 on 9th February 2019 which affected all the inverters. One of the inverters (Inverter 04) did not start with the rest of the inverters at 18:45 on 9th February 2019, instead it was back online on 13:00 of 10th February 2019. Moreover, due to snow settlement on 1st February 2019 there wasn't any generation for half of the day.
